**HAZARDOUS MINE OPENING
MAINTENANCE PROJECT
DSL/AMRB PROJECT NO. 93-M08**

HAZARDOUS MINE OPENING MAINTENANCE PROJECT
DSL/AMRB PROJECT NO. 93-M08

July 1994

RE: Hazardous Mine Opening Maintenance Project - Final Report

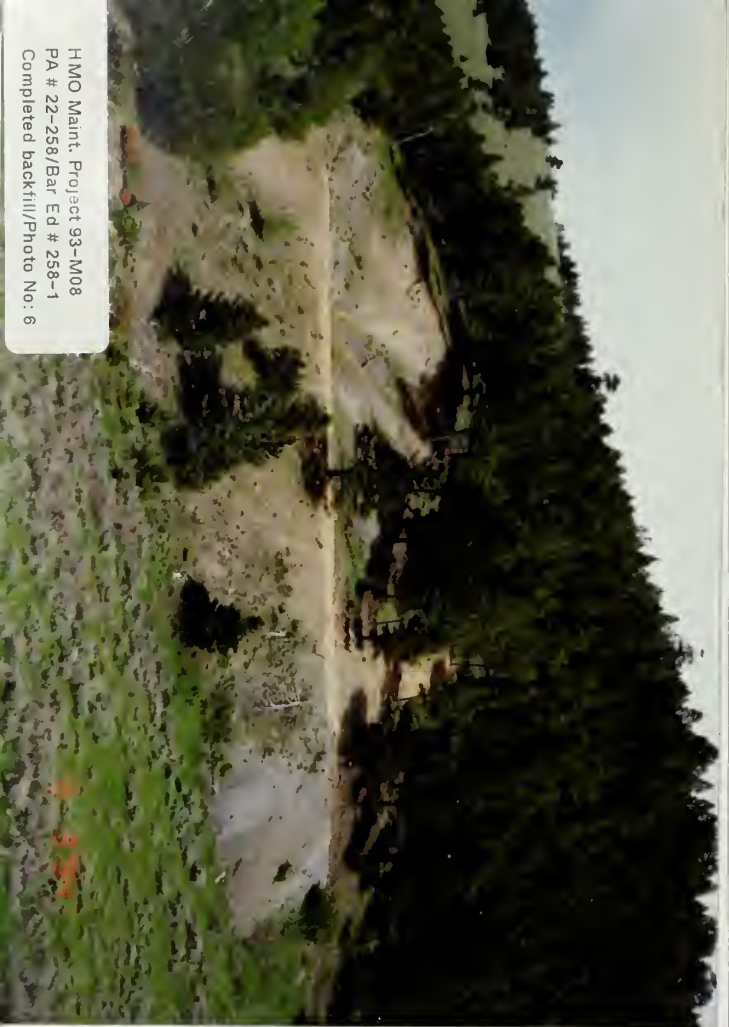
HMO Maint. Project 93-M08
PA # 22-258/Bar Ed # 258-1
Completed backfill/Photo No: 6

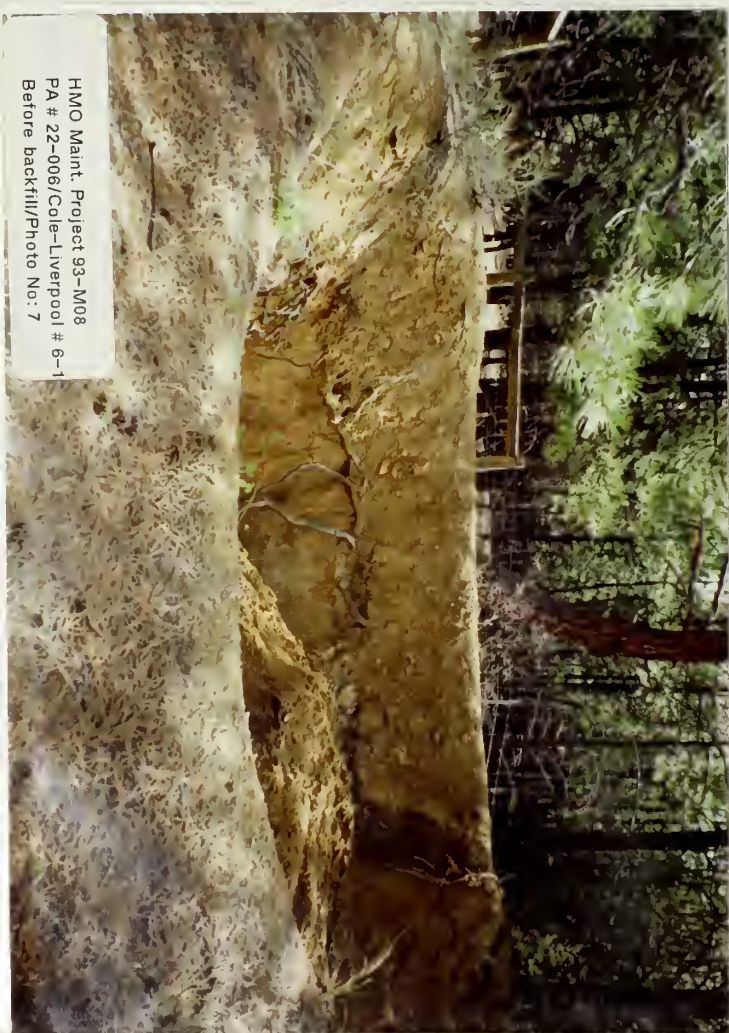
HMO Maint. Project 93-M08
PA # 22-006/Cole-Liverpool # 6-1
Before backfill/Photo No: 7

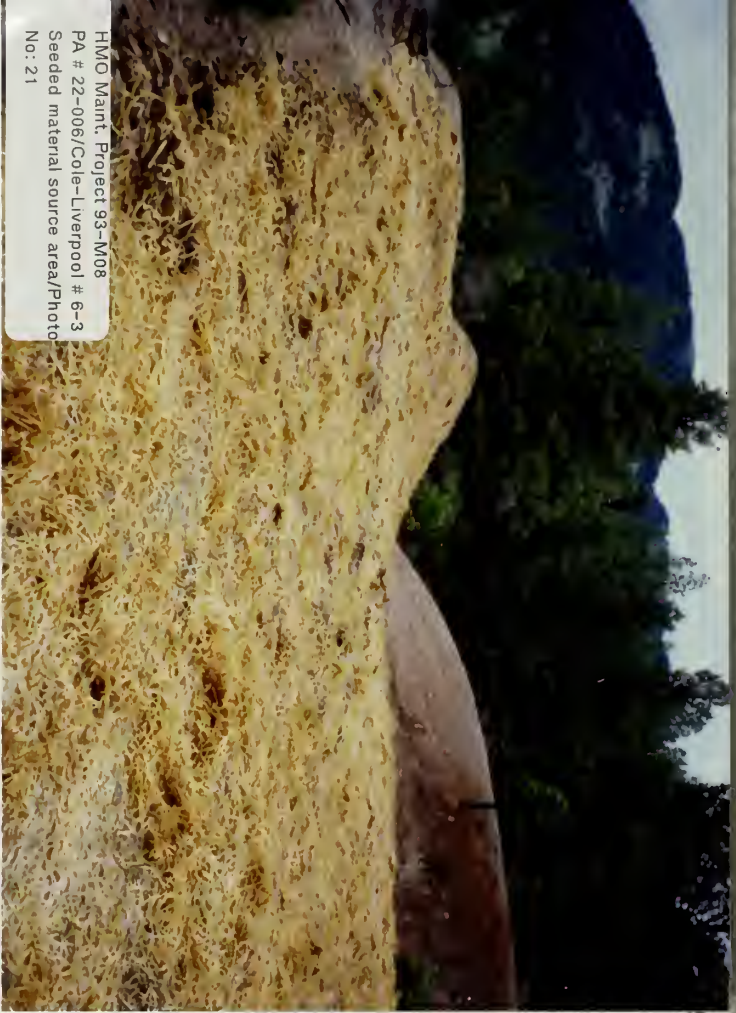
HMO Maint, Project 93-M08
PA # 22-006/Cole-Liverpool # 6-3
Seeded material source area/Photo
No: 21

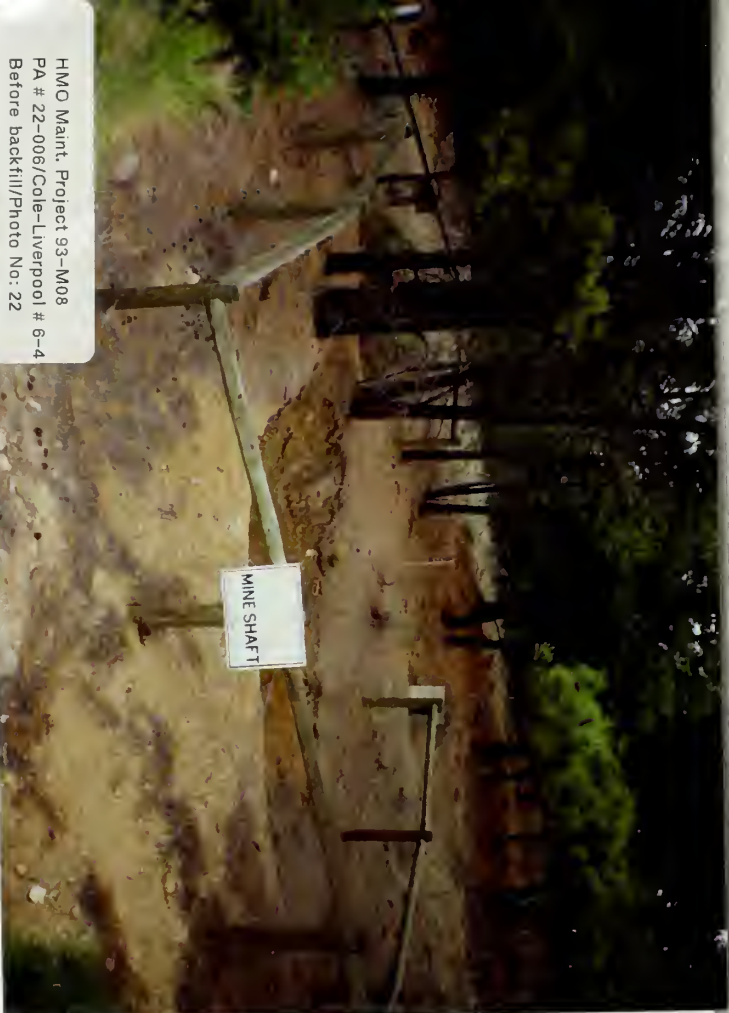
HMO Maint, Project 93-M08
PA # 22-006/Cole-Liverpool # 6-4
Before backfill/Photo No: 22

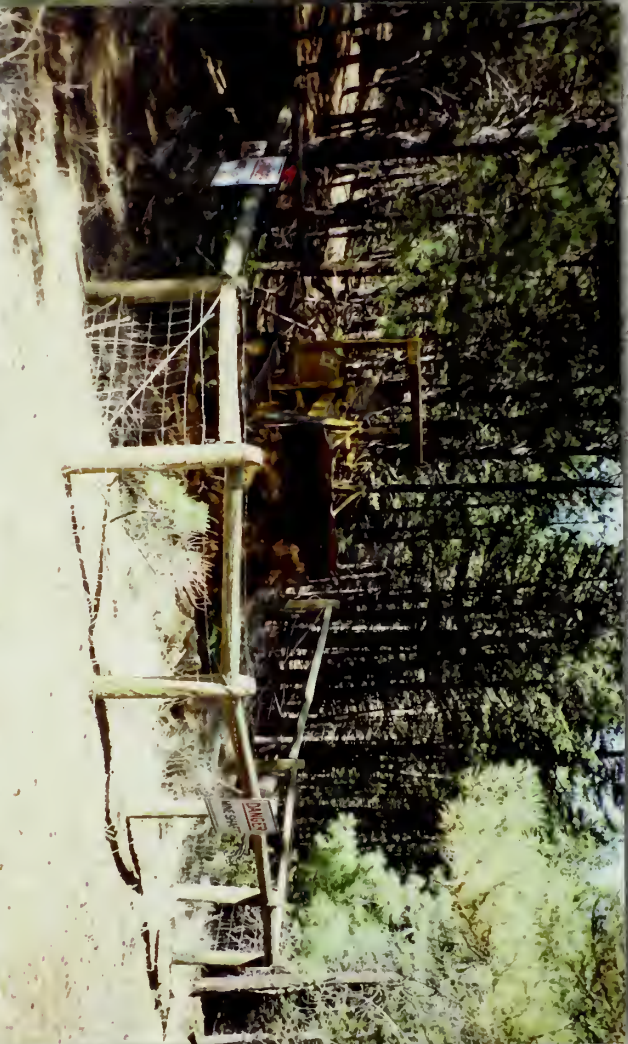
HMO Maint. Project 93-M08
PA # 22-006/Cole-Liverpool # 6-6
Backfilling shaft/Photo No: 30

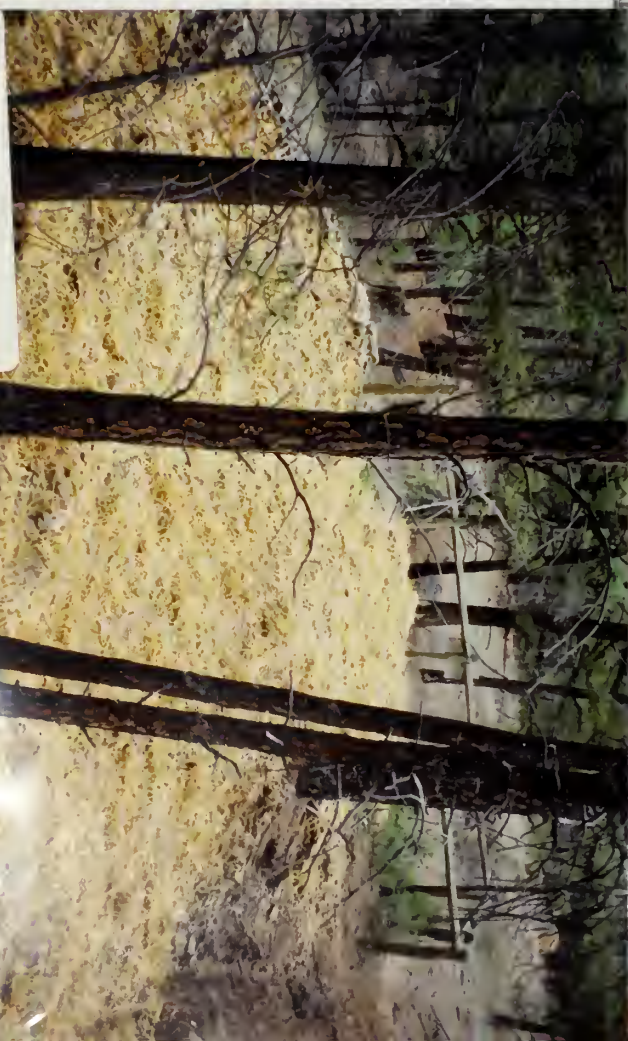
HMO Maint. Project 93-M08
PA # 22-006/Cole-Liverpool # 6-6
Complete backfill/Photo No: 31

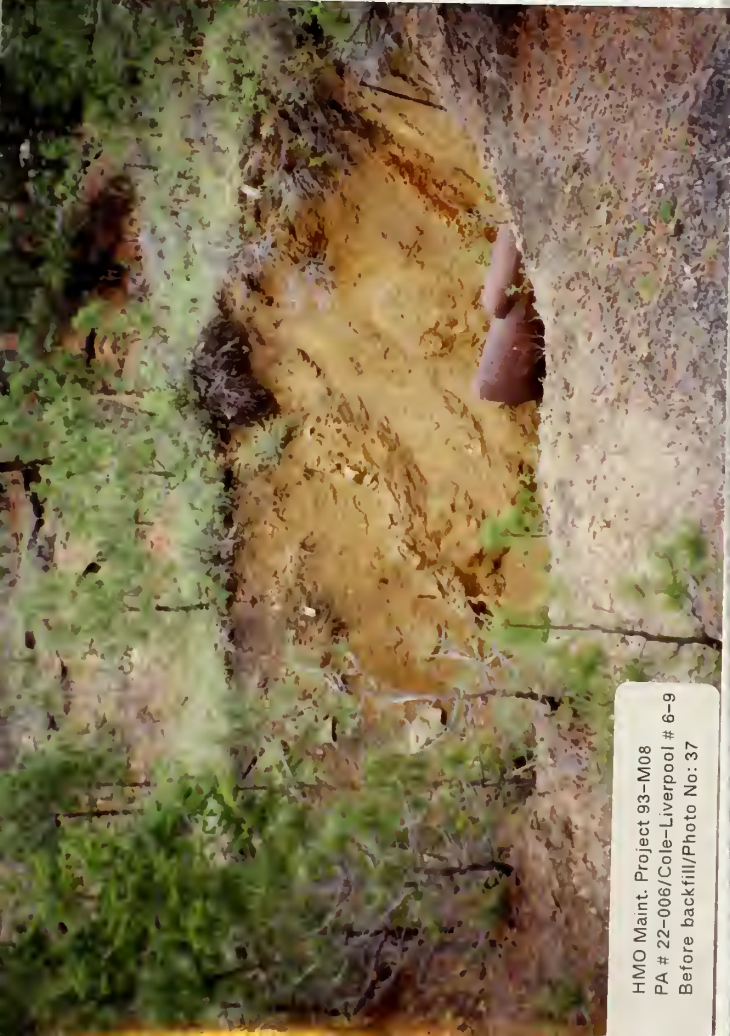
HMO Maint. Project 93-M08
PA # 22-006/Cole-Liverpool # 6-9
Before backfill/Photo No: 37

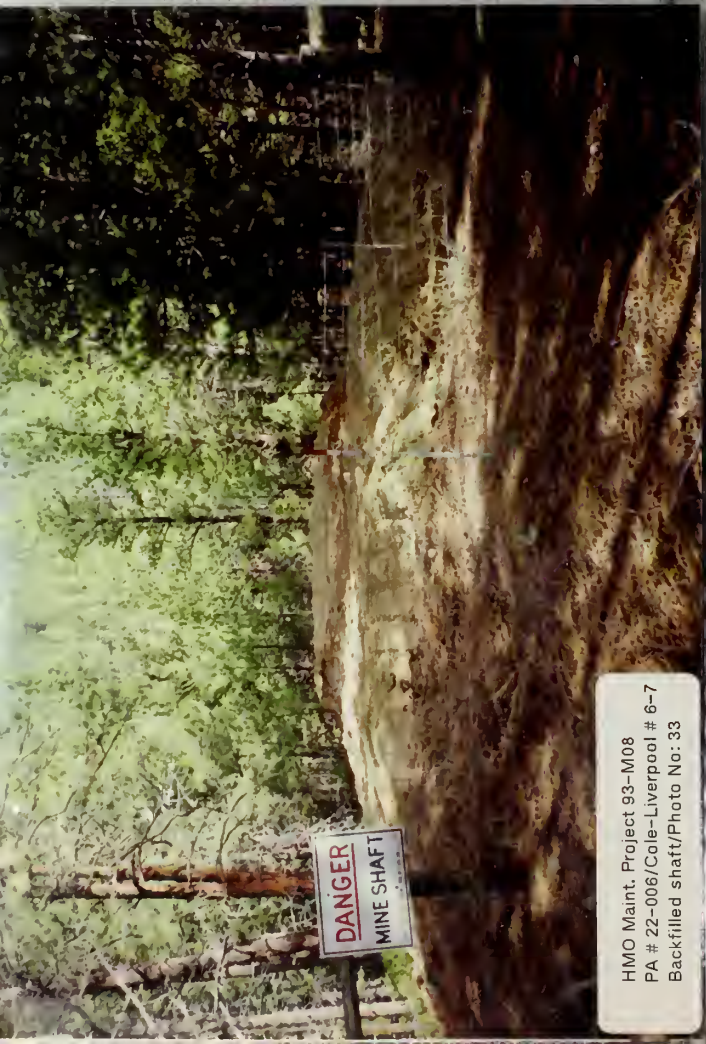
HMO Maint. Project 93-M08
PA # 22-006/Cole-Liverpool # 6-7
Backfilled shaft/Photo No: 33

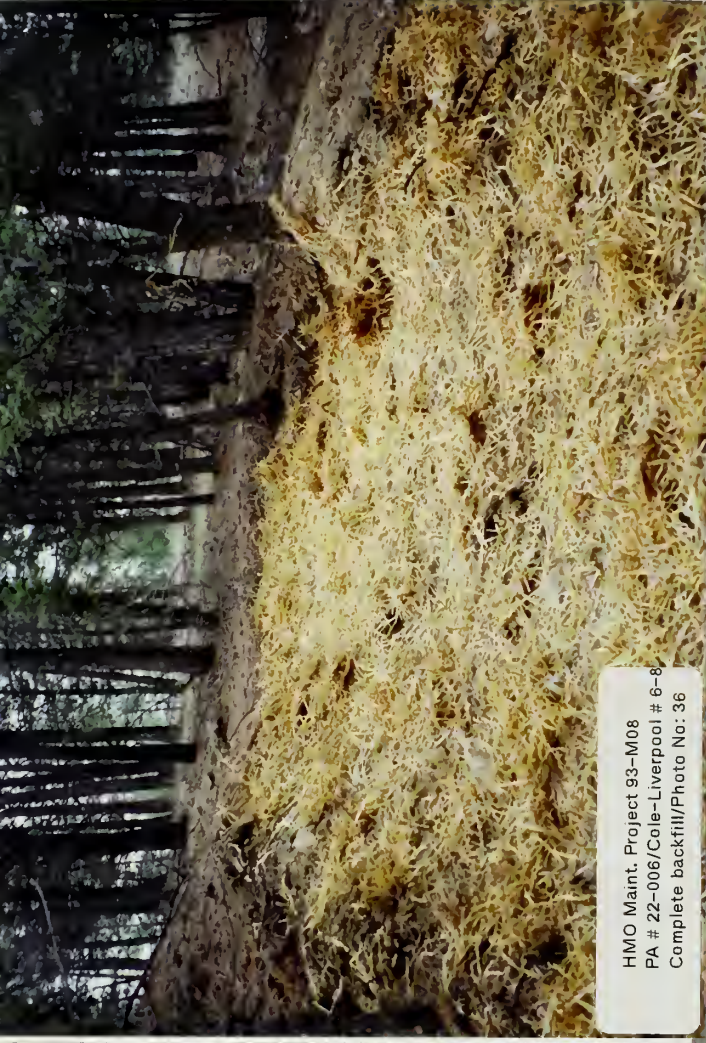
HMO Maint. Project 93-M08
PA # 22-006/Cole-Liverpool # 6-8
Complete backfill/Photo No: 36
